Report Summary

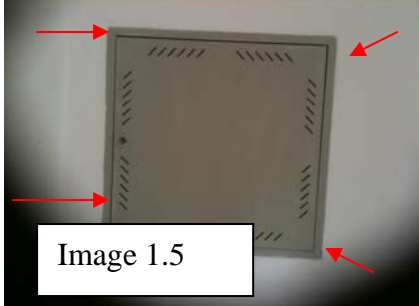
Aluminum window	<ul style="list-style-type: none"> Minor cracks on the internal surface of the architraves (top corner)
	Wall	<ul style="list-style-type: none"> Wall corner uneven
	ACP Panel	<ul style="list-style-type: none"> Poor finishing around the ACP panel (Image 1.5)

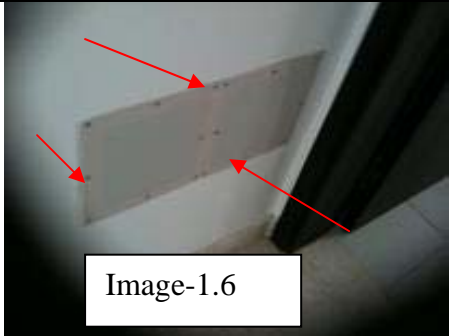
Living Room	Gypsum Ceiling	<ul style="list-style-type: none"> Gypsum ceiling cracks at the joint (Passage way to study room)
	Junction Box	<ul style="list-style-type: none"> Junction box not fixed properly (Passageway to study room) (Image- 1.6)
	Wall	<ul style="list-style-type: none"> Wall uneven left bottom of the study room architraves
		<ul style="list-style-type: none"> Walls not improper finishing. Full painting required (Phinomastic silky)

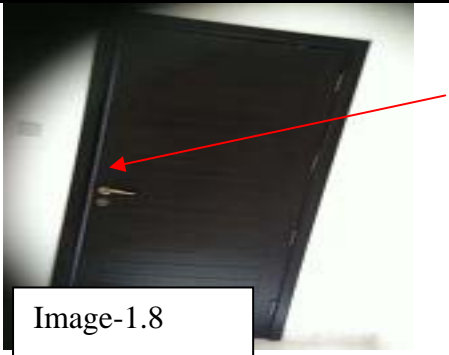
N/A
Study room	Door	<ul style="list-style-type: none"> Alignment required ,door cannot close properly (Image 1.8)
	Architraves	<ul style="list-style-type: none"> Poor finishing around the architraves
	Chandler	<ul style="list-style-type: none"> Chandler top need proper covering

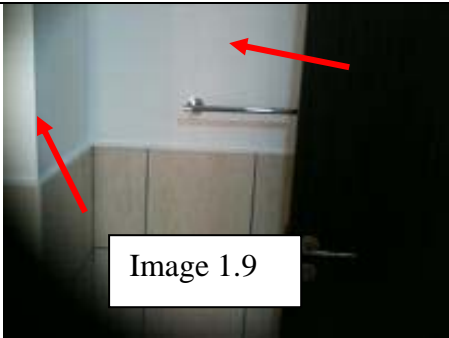
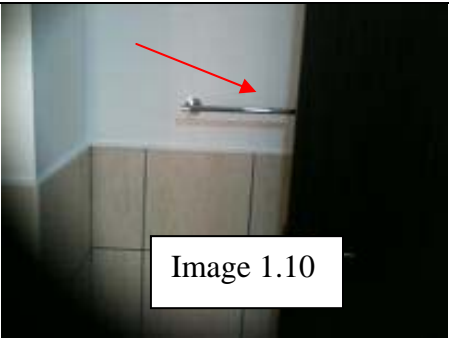
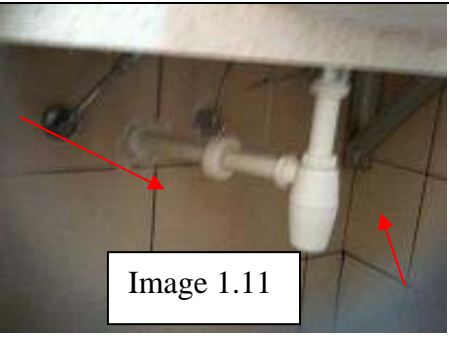
N/A
Attached Toilet	Wall	<ul style="list-style-type: none"> Wall tiles missing some area (As per Mazaya representative , wall tiles will be fixed on plastered wall as part of upgrade)(Image 1.9)
	Mixture tap	<ul style="list-style-type: none"> Poor finishing around the mixture tap-grouting missing some area
	Architraves	<ul style="list-style-type: none"> Poor finishing around the architraves

Towel Holder	<ul style="list-style-type: none"> Towel holder located in wrong place
	Bottle trap	<ul style="list-style-type: none"> Bottle trap area visible(Bottle traps area visible. As per Mazaya representative base cabinet will be installed as part of the upgrading)(Image 1.11)

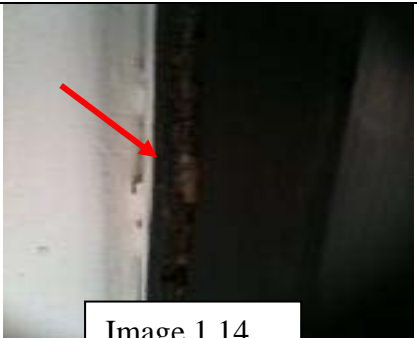
<p>Image 1.14</p>		N/A		N/A	
Maidroom	Door	<ul style="list-style-type: none"> Wooden door chipped near door handle 			
	Door	<ul style="list-style-type: none"> Patchworks on the door not up to satisfactory

<p>Image 1.13</p>		N/A	
Utility Room	Wall	<ul style="list-style-type: none"> Poor workmanship at wall tiles edge beads 			
	Glass window	<ul style="list-style-type: none"> Poor finishing around the aluminum frame glass window 			
	Glass window	<ul style="list-style-type: none"> Glass window rubber beads to be adjusted 			
	Ceiling	<ul style="list-style-type: none"> Ceiling tiles dirty 			
	Exit door	<ul style="list-style-type: none"> Poor finishing around the exit door 			
	Wall	<ul style="list-style-type: none"> Poor finishing between maid room architraves and wall (Left edge to the architraves) (Image-1.14) 			
	Architraves	<ul style="list-style-type: none"> Poor finishing around the architraves

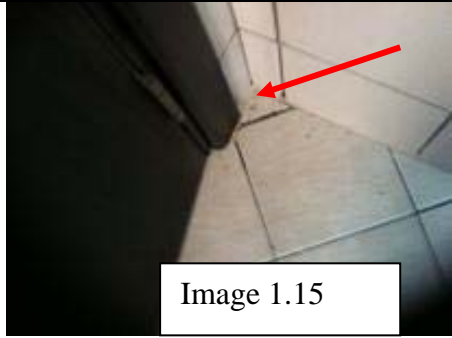
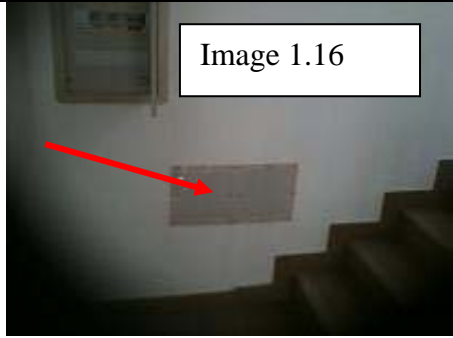
<ul style="list-style-type: none"> Door cannot close properly 			
		<ul style="list-style-type: none"> Poor finishing around the architraves 			
	Glass window	<ul style="list-style-type: none"> Poor finishing around the glass window 			
	Bathroom architraves	<ul style="list-style-type: none"> Poor finishing around the bathroom 			
Maid Bathroom	Architraves	<ul style="list-style-type: none"> Poor finishing around the architraves, Patchworks on architraves 			
	Wall	<ul style="list-style-type: none"> Poor finishing at wall tiles edge beads 			
	Glass Window	<ul style="list-style-type: none"> Poor finishing around the glass window 			
	Flushing	<ul style="list-style-type: none"> Flush not working 			
	Floor	<ul style="list-style-type: none"> Corner tiles damaged right bottom of architraves (Image 1.15) 			
		<ul style="list-style-type: none"> No proper slope towards the floor trap. 			
Staircase lead to 1 st floor	Junction box	<ul style="list-style-type: none"> Junction box not fixed properly (Entry to staircase left) (Image 1.16)

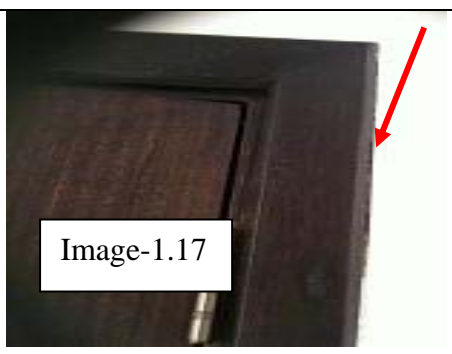
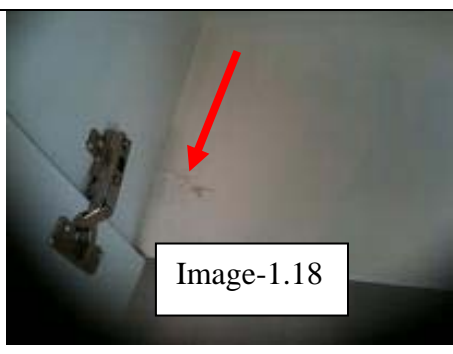
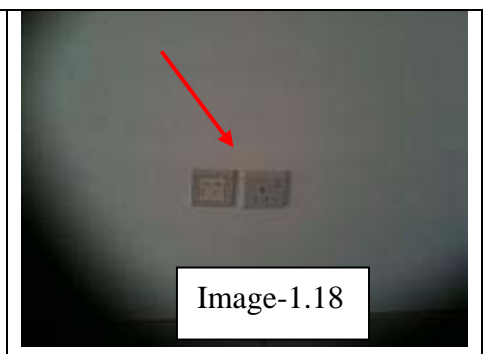
Bedroom	Architraves	<ul style="list-style-type: none"> Patchworks on the architraves, Poor finishing around the architraves Small wooden piece fixed to fill the architraves gap-not acceptable (image 1.17)
	Door	<ul style="list-style-type: none"> Alignment required on door
	AC Grill	<ul style="list-style-type: none"> Minor gaps around the AC grill
	Wardrobe	<ul style="list-style-type: none"> Wardrobe bottom rack damaged (Image 1.18) Wardrobe door alignment required
		<ul style="list-style-type: none"> Balcony door bottom tiles edge beads poor finishing Power sockets and data sockets alignment required (1.19)
	Balcony Door	<ul style="list-style-type: none"> Poor finishing around the balcony door

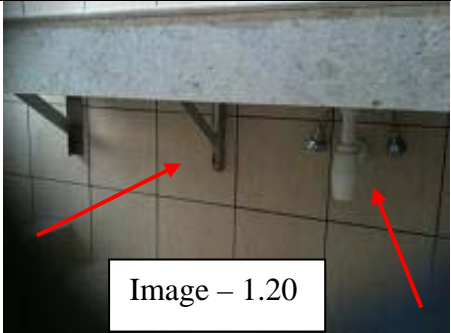
<ul style="list-style-type: none"> Poor grouting bottom of the architraves
Master Bedroom	Architraves	<ul style="list-style-type: none"> Poor finishing around the architraves
	Door	<ul style="list-style-type: none"> Scratches on the door
Master Bedroom-Dressing room	Wardrobe	<ul style="list-style-type: none"> Poor finishing around the wardrobe Wardrobe drawer hinges loosened Wardrobe alignment required
		<ul style="list-style-type: none"> Wardrobe alignment required
Master bedroom Attached toilet	Architraves	<ul style="list-style-type: none"> Poor finishing around the architraves
	Bathtub	<ul style="list-style-type: none"> Bathtub and separate shower missing
	Bottle trap	<ul style="list-style-type: none"> Bottle traps area visible. As per Mazaya representative base cabinet will be installed as part of the upgrading (Image 1.20)
	Towel holder	<ul style="list-style-type: none"> One towel holder missing

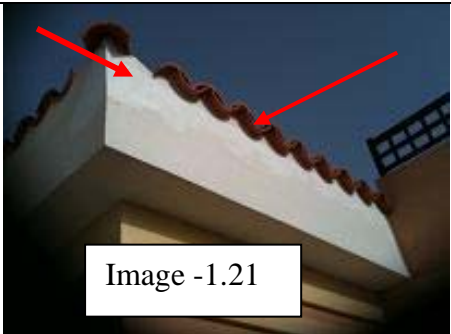
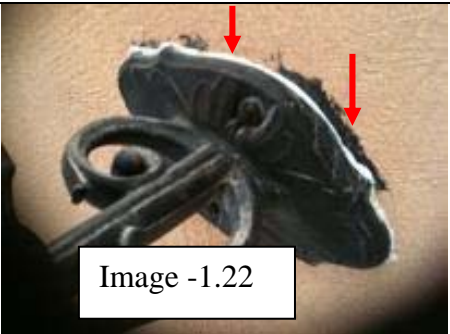
Balcony	Balcony top external paint	<ul style="list-style-type: none"> • White paint applied not matching with existing white paint (Image-1.21)
	Concrete architraves	<ul style="list-style-type: none"> • Balcony concrete architraves uneven
		<ul style="list-style-type: none"> • Minor gap around the wall mounted lamp (Image - 1.22)

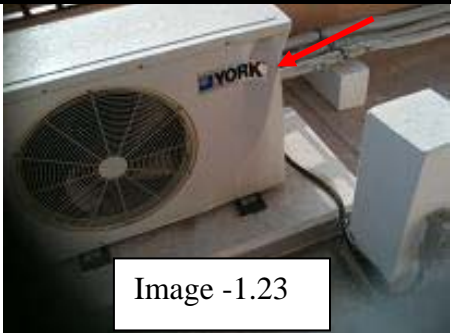
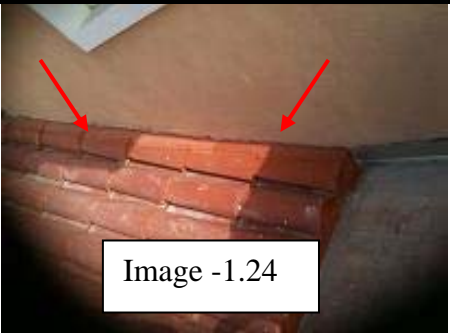
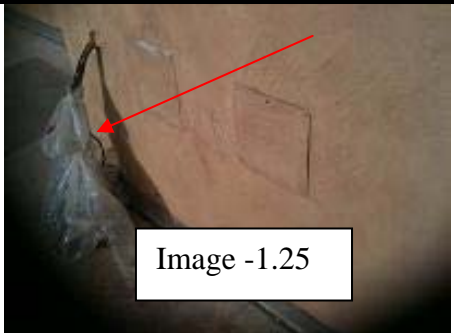
Roof	AC External Unit	<ul style="list-style-type: none"> • One of the external unit body damaged (Image 1.23) • Roof glay tiles cracked (Image-1.24) • Extra cable lying on roof

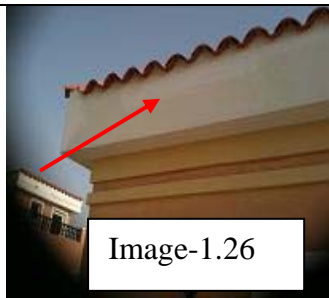
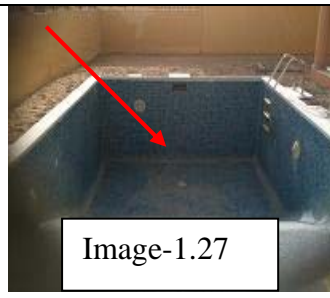
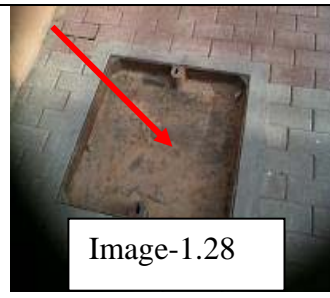
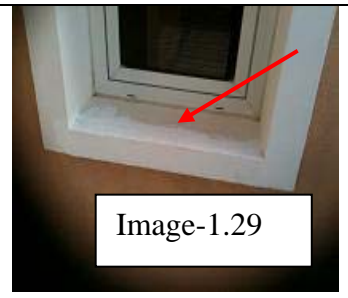
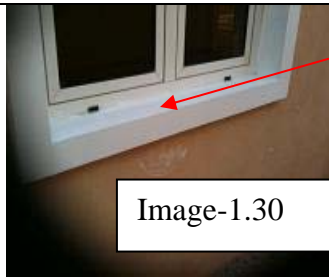
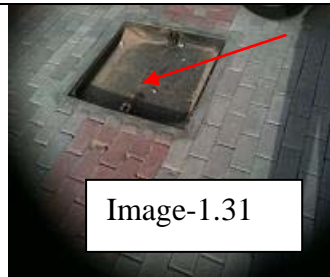
External	Roof Surface	Paint touch up not matching with existing white color (Image-1.26)
	Swimming pool	Swimming pool left without water. Due to high temperature tiles may chipped off –(must keep with water)(Image-1.27)
	Manhole cover	Interlock missing (Image 1.28 & 1.31)
		Ladder joint coupling broken (Image 1.37)
	Window	Poor finishing around the window(All) – Image 1.29,130 & 1.34)
	Texture fence wall	Texture paint missing- not matching with existing color(Image 1.32)
	Texture building external wall	Texture paint peel off some area (Image 1.36)
	Booster pump panel	Drawings kept inside the panel (Image 1.35)
