INTRODUCTION

The summary below consists of potentially significant findings. These findings can result to be a major expense to rectify or to replace. This report does not claim to cover/list all the findings during the survey and can only reflect the opinion of the inspector based on experience and best practice according to international industry standards. It is always recommended to engage only professional and licensed companies to do the repairs. We recommend obtaining a copy of all receipts, warranties and permits for the work done.

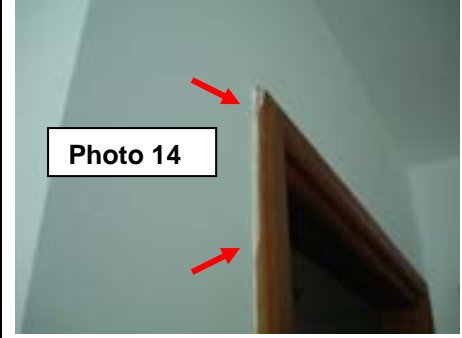
<p>Photo 14</p>

Storage room	Door	<ul style="list-style-type: none"> ▪ Poor finishing around the architrave. (Refer photo 14) ▪ Excess paint/sealant to be removed from architrave. ▪ Grout missing at bottom of architrave. (Refer photo 15) ▪ Scratches found on door. (Refer photo 16) 	
		Ceiling	<ul style="list-style-type: none"> ▪ Excess paint to be removed from ceiling frame. Especially on the corner perimeter. (Refer photo 17) ▪ Termination of wall and ceiling to be improved. ▪ Ceiling tiles are vibrating due to the air pressure differential between the living room and the toilet whenever the door is being opened or closed.
			<ul style="list-style-type: none"> ▪ Handmarks/stain found on the wall. (Refer photo 18) ▪ Poor finishing works around utility devices. Excess paint to be removed. Even paint and texture to be applied around. (Refer photo 18)
		Wall	<ul style="list-style-type: none"> ▪ Poor finishing works around utility devices. Excess paint to be removed. Even paint and texture to be applied around. (Refer photo 18)

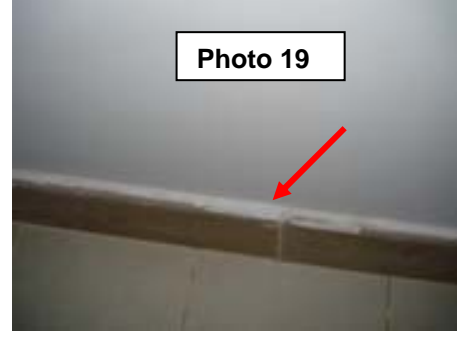
Skirting	<ul style="list-style-type: none"> ▪ Poor finishing on top of skirting. Excess paint or grout to be removed. (Refer photo 19)

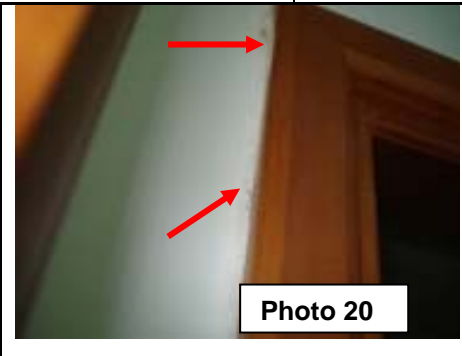
<p>Photo 20</p>

<p>Photo 19</p>
<p>Guest toilet</p>	<p>Door</p>	<ul style="list-style-type: none"> ▪ Poor finishing around the architrave. (Refer photo 20) ▪ Excess paint/sealant to be removed from architrave. ▪ Grout missing at bottom of architrave. ▪ Crack on surface of the door found beside lower hinge. (Refer photo 21) ▪ Minor and deep scratches found on the surface of the door. (Refer photo 22)
	<p>Ceiling</p>	<ul style="list-style-type: none"> ▪ Ceiling tiles are vibrating due to the air pressure differential between the living room and the toilet whenever the door is being opened or closed.
	<p>Wall</p>	<ul style="list-style-type: none"> ▪ No bidet holder provided. (Refer photo 23)
		<ul style="list-style-type: none"> ▪ Water supply valve of water closet not properly flushed on the wall. (Refer photo 24)

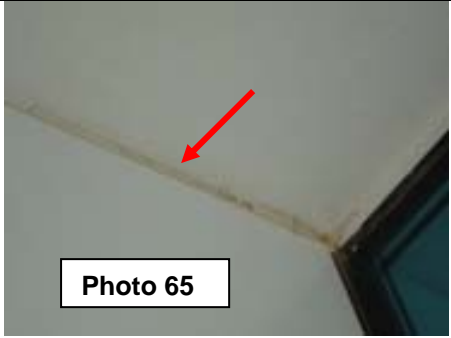
Balcony	General	<ul style="list-style-type: none"> ▪ Poor sealant works between aluminum façade and overhead canopy. (Refer photo 65) ▪ Scratches found on aluminum facade. ▪ Removal of sand and dirt on balcony required. (Refer photo 66) ▪ Uneven floor tiles found on some area. (Refer photo 67)
---------	---------	--

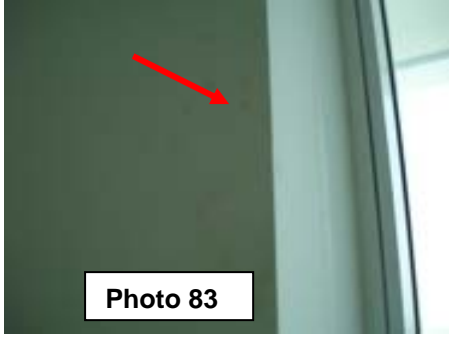
<p>Photo 83</p>

<ul style="list-style-type: none"> Scratches found on door surface internal. (Refer photo 78)
		<ul style="list-style-type: none"> Stains/marks found on the internal surface of wardrobe closet.
<ul style="list-style-type: none"> Alignment of door required. Internal door surface rubbing with the frame. (Refer photo 78) 		
<ul style="list-style-type: none"> Touch ups of internal surface of the door to be rectified up to the satisfactory level. (Refer photo 79) 		
Curtain wall	<ul style="list-style-type: none"> Poor finishing on internal joints. (Refer photo 80) 	
	<ul style="list-style-type: none"> Stains/marks found around the opening of the curtain wall. (Refer photo 83) 	
	<ul style="list-style-type: none"> Poor finishing works around curtain wall. (Refer photo 84, 85, 86 & 87) 	
	<ul style="list-style-type: none"> Excess sealant to be removed from frame corners and joints of curtain wall frame. (Refer photo 85)

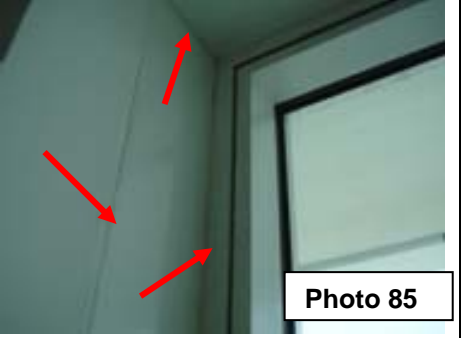
<p>Photo 85</p>

<ul style="list-style-type: none"> Scratches found on the curtain wall frame. (Refer photo 85, 86 & 87)

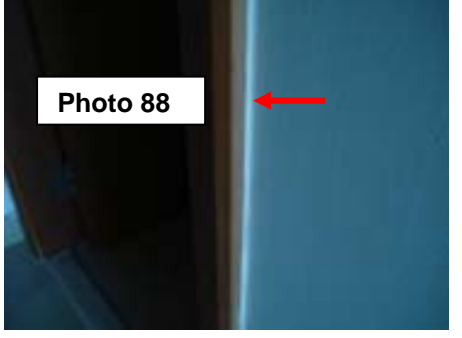
<p>Photo 88</p>

<p>Photo 87</p>	
<p>Bedroom 1 toilet</p>	<p>Door</p>	<ul style="list-style-type: none"> ▪ Poor finishing around and bottom of the architrave. (Refer photo 88) ▪ Excess paint/sealant to be removed from architrave. ▪ Poor finishing of architrave joints to be improved. ▪ Scratches on surface of architrave. ▪ Visible rectification of surface of architrave to be improved. (Refer photo 89)
	<p>Ceiling</p>	<ul style="list-style-type: none"> ▪ Exhaust fan grill not properly centered on the ceiling tile. (Refer photo 90)
	<p>Wall</p>	<ul style="list-style-type: none"> ▪ Poor sealant works around shower basin. (Refer photo 91) ▪ Poor finishing works around shower glass. Excess sealant to be removed (Refer photo 92)
	<p>Floor</p>	<ul style="list-style-type: none"> ▪ Floor drain screw missing. (Refer photo 93)
