Report Summary

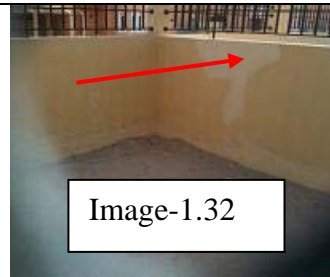
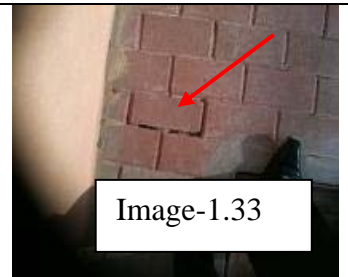
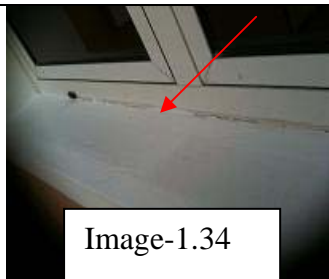
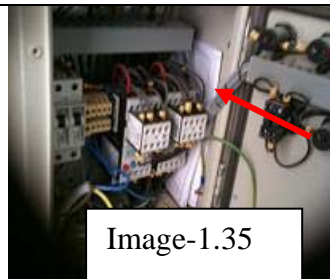
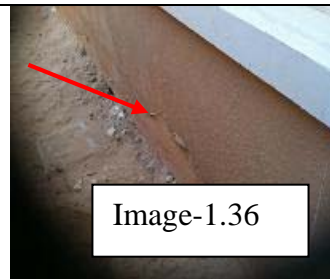
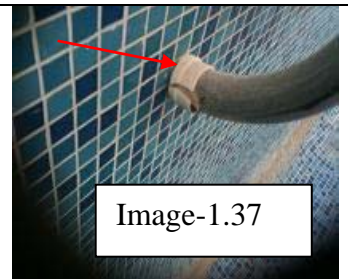
External	Roof Surface	Paint touch up not matching with existing white color (Image-1.26)
	Swimming pool	Swimming pool left without water. Due to high temperature tiles may chipped off –(must keep with water)(Image-1.27)
	Manhole cover	Interlock missing (Image 1.28 & 1.31)
		Ladder joint coupling broken (Image 1.37)
	Window	Poor finishing around the window(All) – Image 1.29,130 & 1.34)
	Texture fence wall	Texture paint missing- not matching with existing color(Image 1.32)
	Texture building external wall	Texture paint peel off some area (Image 1.36)
	Booster pump panel	Drawings kept inside the panel (Image 1.35)
